The Study of Developing Asphalt Patch Slabs on Repairing Pavement Potholes (ID#805)

The 9th International Conference on Road and Airfield Pavement Technology

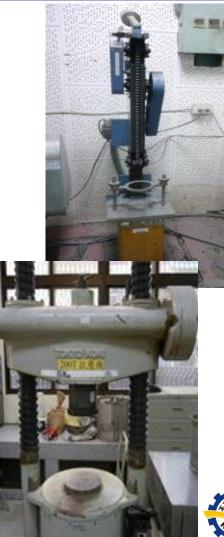
- One dense graded asphalt concrete (DGAC) mix design was selected to produce asphalt slabs.
 - Slabs were produced compaction method by Marshall compactor or compression method by UTM machine.
 - Targeted thickness: 50- and 60mm

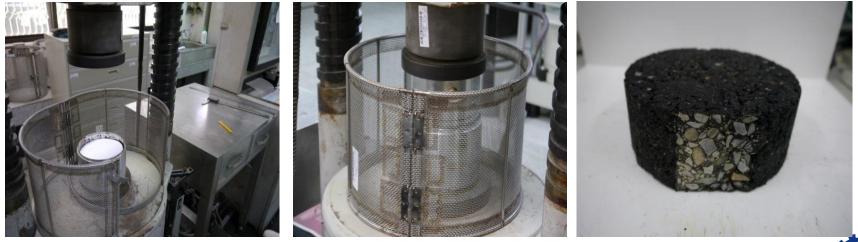
- Comparisons of compaction and compression methods.
 - The compression method through UTM machine, either one-side or double-side approach, reached to 6.8% or 6.45%.

(Photos taken by DGH)
